PITTSBORO COMMUNITY HOUSE

2012 SCHEMATIC FEASIBILITY REPORT

HOBBS ARCHITECTS, PA

Report of Findings and Recommendations

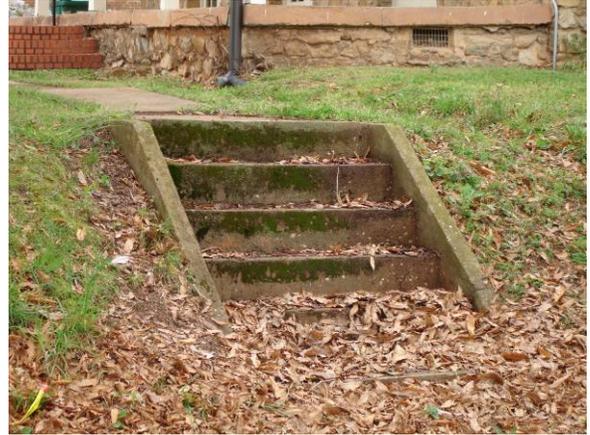
The primary landscaping feature around the building consists of sloped grassy areas. Some erosion was noted on the east side adjacent to the stairs leading from the driveway to the front entrance. A new BMP was installed at the rear of the property with wetland grasses and other environmentally sustainable features as designed and installed by NC State. This Stormwater retention system receives run-off from an adjacent impervious parking lot.

PIT002: Stairs at Southeast corner of building
- ground erosion evident to north of stairs

- Recommend replacing sidewalks due to cracks and heaving.
- Parking should include marked handicap parking spaces.
- Ramp and stairs to access building should be installed to meet ADAAG Guidelines.
- Stabilize ground to correct ground erosion near house; replace RCP under driveway at northeast corner of building; a retaining wall should be added where the elevation changes on the east side adjacent to stairs leading to the front entrance.

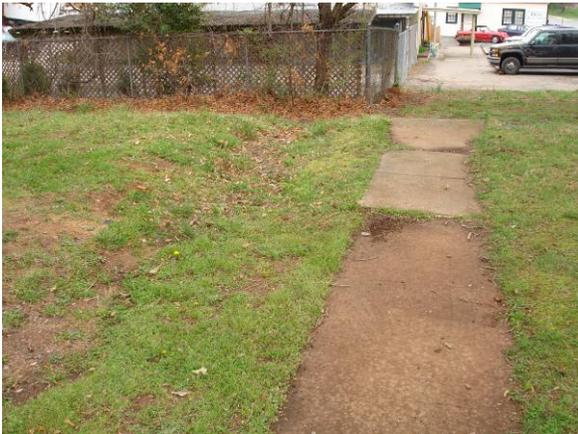
The building is surrounded by a narrow pedestrian sidewalk that was found in poor condition. It is recommended that the sidewalk be removed; soil scrapped and re-compacted, then place new concrete over appropriate base. Handicapped access is not available at any of the entrances. A sidewalk ramp should be provided on the west side of the building from a pull-off area from the driveway leading to the front porch for entry through the main doors. The stairs at the main entry are not original nor ADA compliant. It is recommended that these be replaced with ADA compliant stairs and railings as part of the ramp project. The porch on the front of the building has significant deterioration and cracking. A project is currently in the planning stages to have this repaired.

PIT003: Typical Crack in Sidewalk view toward stairs
seen in photo Site 02

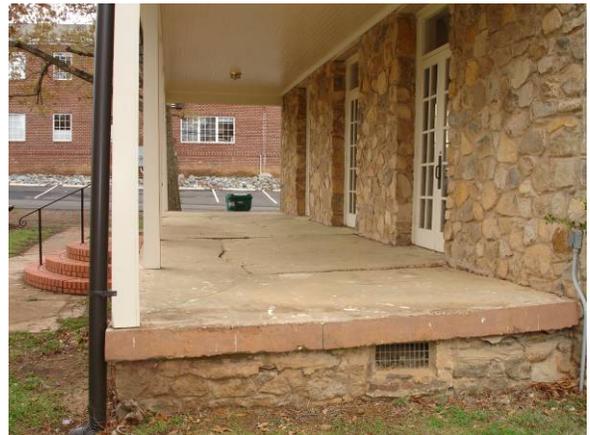
PIT004: Concrete deterioration on Porch

- It is recommended that new windows in keeping with the original windows design be installed where existing windows are missing.
- Porch floor should be removed and replaced with compacted stone fill and minimum 4" reinforced concrete slab. Rebar should be treated for exterior use.

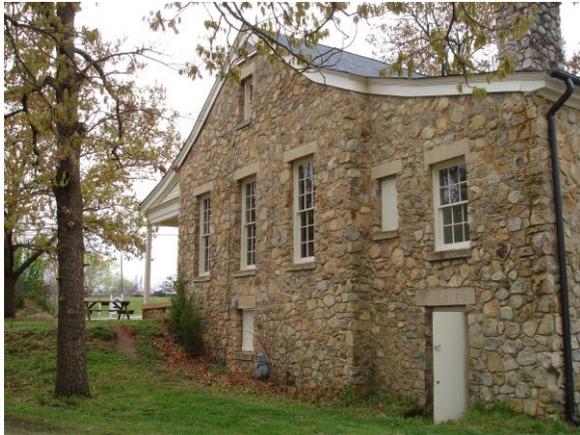
- Cracking in the exterior walls is evident primarily due to ground erosion. It is recommended that site erosion stabilization measures be performed which should prevent further cracking to the building. Exterior walls should be cleaned and grout repointed where cracks have occurred.

PIT011 – East Elevation – View of ground erosion, masonry cracks and blocked windows.

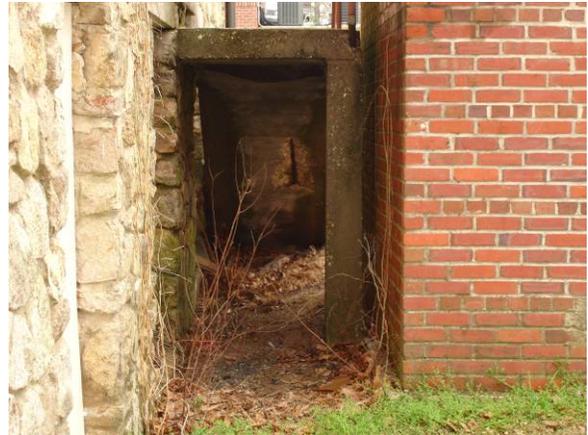
The exterior stairs on the south elevation are brick while the stairs on the north and west elevations are concrete. None of the stairs or handrails are ADA Compliant. The stairs on the north and west elevations have significantly deteriorated. Rebar is exposed on the under side of the north stairs. It is recommended that all stairs be replaced with ADA Compliant stairs and handrails.

PIT017: North Stairs – View of underside of stairs with exposed rebar in concrete.

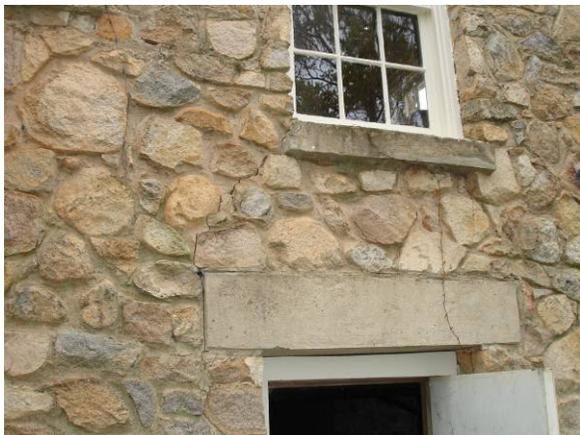
PIT012: East Elevation - Typical crack in masonry

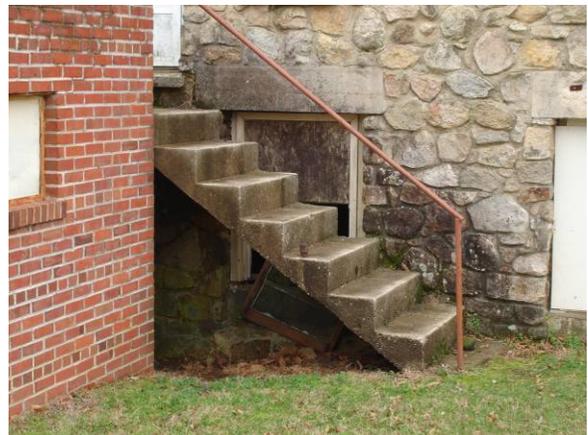
PIT018: North Stairs– Non Compliant stairs & handrail

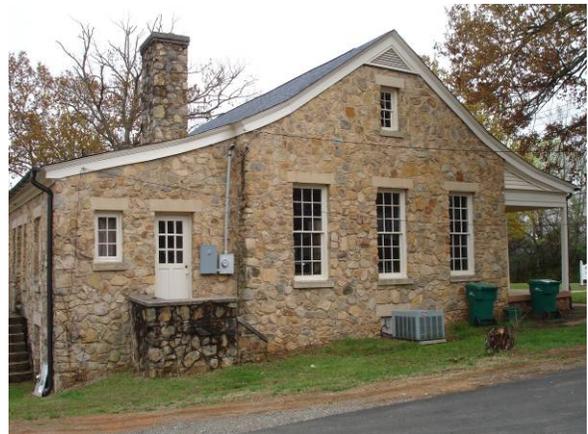
PIT021: West Elevation – Non Compliant entry

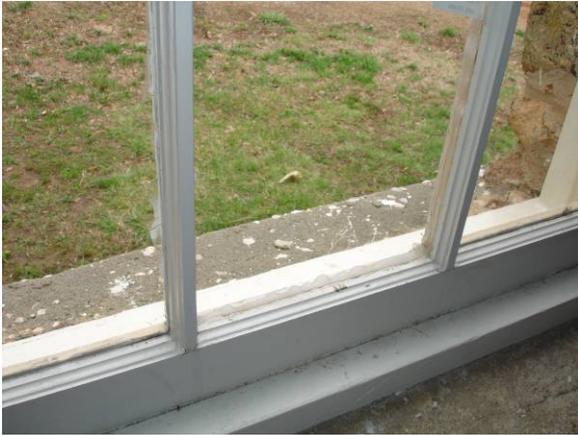
- The original building windows are single pane glass which provides poor thermal comfort for building occupants. Much of the existing glass has been replaced with glass or Plexiglas. The replacement method is not consistent nor is the craftsmanship of good quality. The major support mullions appear to be in good condition. It is recommended that the windows be repaired and interior-mounted storm windows be installed.

PIT024: West Elevation – Glass replacement; poor craftsmanship

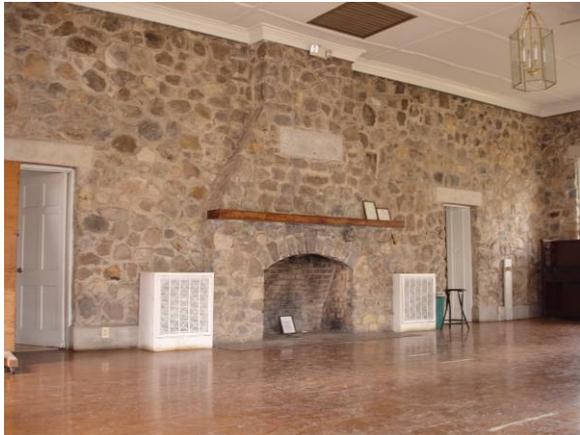
PIT025: Main Room – Interior View. AC components overwhelm historic nature of room.

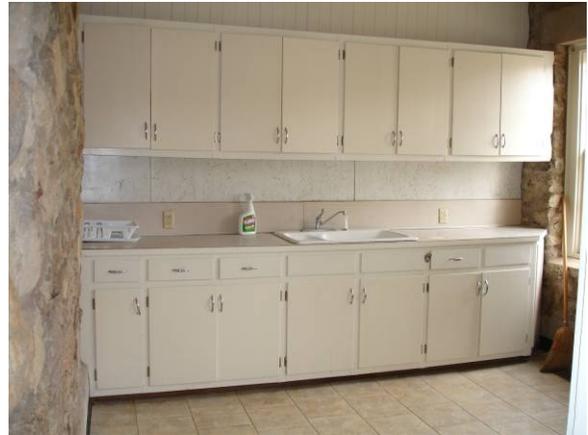
PIT037: View of Kitchen – Casework in poor condition and kitchen is not ADA Compliant

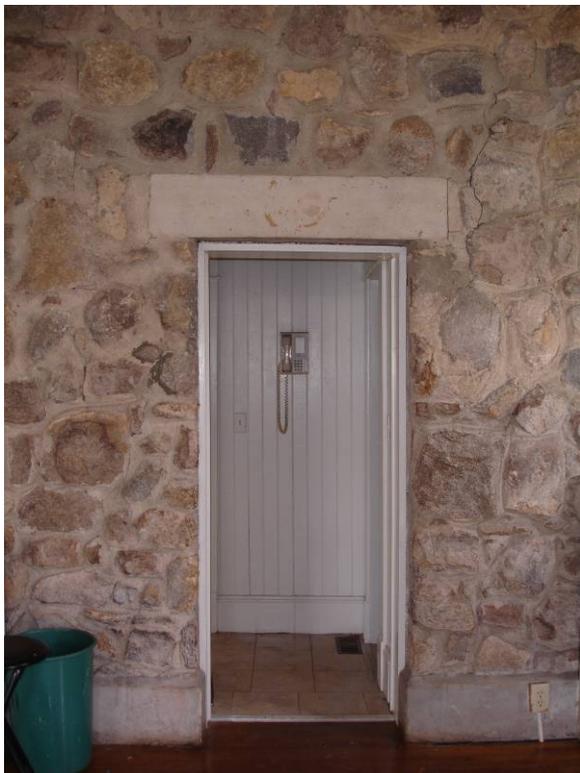
PIT032: View of doorway from Main Room to back of house area – Not ADA Compliant

- The doorways from the main room to the back of the house are not ADA Compliant. As part of a reconfiguration of the back of the house, it is recommended that these be kept as cased openings without doors and the openings should be modified slightly to allow for a 32" wide clearance.
- Neither of the two toilet rooms are ADA-compliant; a minimum of one should be provided.
- None of the door hardware is ADA-compliant; it is recommended that the door hardware be changed to lever.
- The kitchen is not ADA-compliant which should be provided.

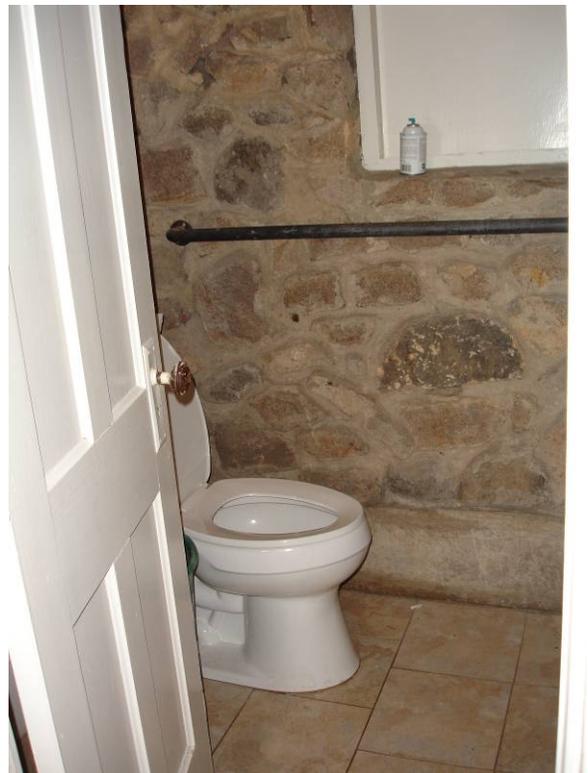
PIT033: Toilet Room – Not ADA Compliant

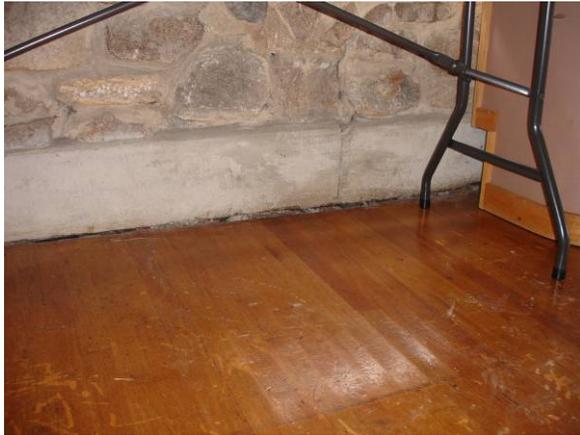
PIT030: Main Room – Gap between base and wood flooring

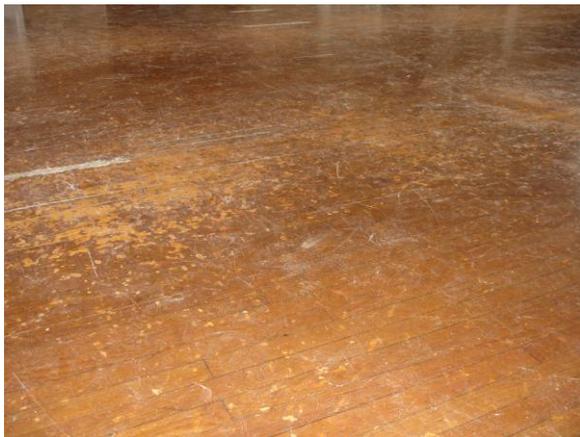
PIT029: Main Room – Damaged areas and finish worn on wood flooring

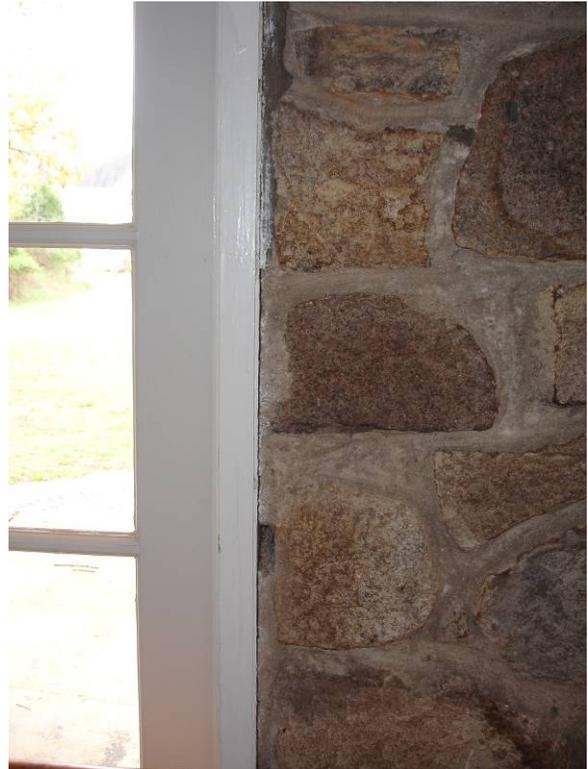
- The ceiling and other building finishes should be upgraded to meet the needs for the future usage.
- Gaps between exterior fenestrations (doors and windows) and stone masonry are visible in places. The mortar should be repointed as needed to prevent water infiltration and provide better thermal conditioning.

PIT028: Minor gaps between exterior fenestrations and stone masonry
